**Flood Control Project Maintenance
Levee Inspections**

Maintenance Issue Types Only, Levee Inspection Report By Mile - Spring 2020

Reclamation District No. 0536 Egbert

Waterway	Bank	Unit Miles	Inspection Start/End	Inspector
Unit No. 01 Lindsey Slough	Right	5.58	04/15/2020 04/15/2020	David Julian

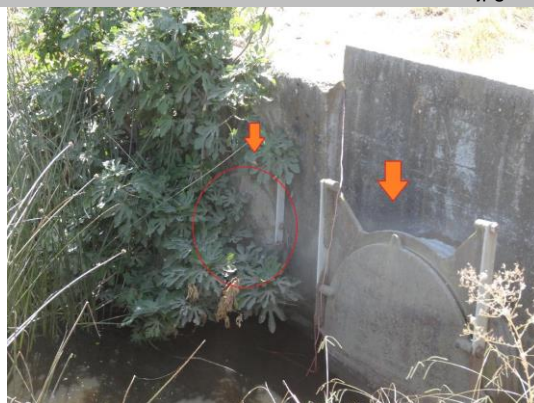
Photo 1 of 3 : UCIP_SP_2020_53359_34457.jpg

DS_ID:22712
FS_ID:53359
EP_NO: 10114
Repair Type: Urgent
Crossing Status: Found
UCIP Comments: 10/2/2018 Holes present in pipe pose internal levee threat; keeping as Urgent (D. Sanoski - DWR UCIP).06/01/2016: Holes and heavy corrosion inside pipe on WS have gotten worse. Flapgates appear in good condition though vegetation blocks view of flapgate for 36-inch on WS. These pipes are still in use and necessary for drainage; pipes may be eligible for repair under DWR Deferred Maintenance Program. (K. Fazel - UCIP)08/13/2013:- Holes in pipe outlet due to heavy corrosion.- Needs detailed investigation of the pipe.- Headwall cracked and tilted on WS. (P. Amatya - DWR)
FIELD_STRUCT_DESC: 1 of 2: 60-inch corrugated metal gravity drainage pipe through the levee, 10 feet below the crown. Flap gate on the waterside (WS). Headwall on each end. Culverts run under the road to provide drainage from agricultural fields via a landside (LS) ditch to Lindsey Slough. No. 100 gate in the LS drainage ditch. Reclamation District No. 536 (RD0536) president is David Hearn at hearnd5@gmail.com. (Retention of one 60-inch and one 36-inch drainage pipes through the levee, 10 feet and 6.5 feet below the crown, respectively, and flap gates on the WS ends authorized under Automatic Board Order (ABO) issued as Permit No. 10114, 1974 - H. E. Peterson). [Additional Reference(s): DWR Levee Log, 1992. USACE Sacramento O&M Manual 106, May 1953, (Station 294+49 "'A'"), invert elevation 14.4 feet].

WS view: two CMPs with flap gates. Concrete headwall supports the pipes. A 36" CMP (left) and 60" CMP (right).

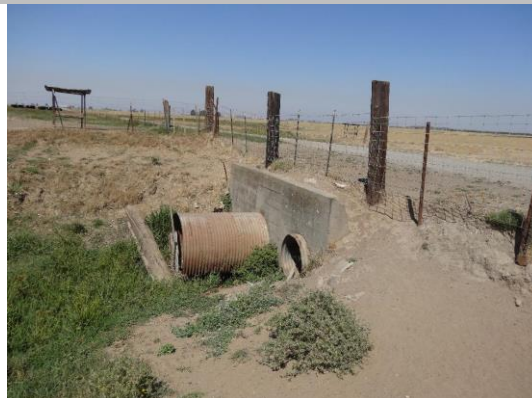
Photo 2 of 3 : UCIP_SP_2020_53359_34456.jpg

LS view: two inlet CMPs with flap gates. Concrete headwall supports the pipes. A 36" CMP (right) and 60" CMP (left).

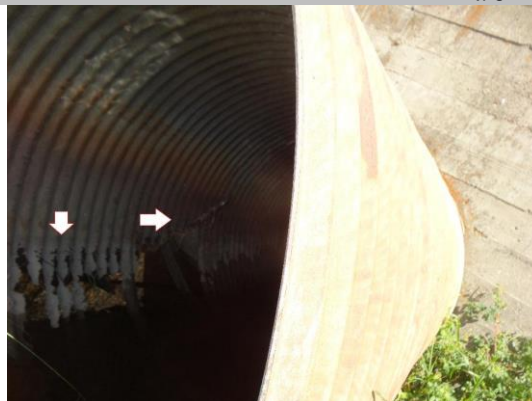
Photo 3 of 3 : UCIP_SP_2020_53359_34455.jpg

LS view: holes & cracks on CM pipe due to heavy corrosion. Needs detailed investigation of the pipe.

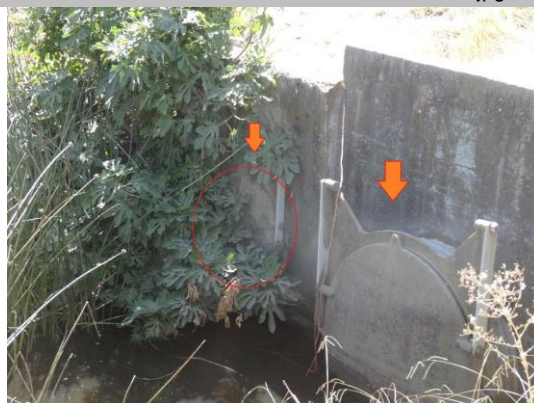
Photo 1 of 3 : UCIP_SP_2020_53360_34771.jpg

Comment Code					
Inspector Comment					
DS_ID:22726 FS_ID:53360 EP_NO: 10114 Repair Type: Urgent Crossing Status: Found UCIP Comments: 10/2/2018 Vegetation blocked WS view of pipe, though a hole directly above WS inlet pipe could be a sinkhole. Keeping as Urgent and recommend internal inspection due to holes in 60-inch pipe (D. Sanoski - DWR UCIP).06/01/2016 Pipe is not abandoned. Though neglected, it is still functional and a needed system feature. Pipe is severely corroded with holes in it, which are visible on LS. Vegetation blocks view of flapgate on WS. Pipes may be eligible for repair under DWR Deferred Maintenance Program. (K. Fazel - UCIP)08/13/2013 This pipe seems to be abandoned. Headwall cracked and tilted on WS. (P. Amatya) FIELD_STRUCT_DESC: 2 of 2: 36-inch corrugated metal gravity drainage pipe through the levee, 10 feet below the crown. Flap gate on the waterside (WS). Headwall on each end. Culverts run under the road to provide drainage from agricultural fields via a landside (LS) ditch to Lindsey Slough. No. 100 gate in the LS drainage ditch. Reclamation District No. 536 (RD0536) president is David Hearn at hearnd5@gmail.com. (Retention of one 60-inch and one 36-inch drainage pipes through the levee, 10 feet and 6.5 feet below the crown, respectively, and flap gates on the WS ends authorized under Automatic Board Order (ABO) issued as Permit No. 10114, 1974 - H. E. Peterson). [Additional Reference(s): DWR Levee Log, 1992, referenced as 6.5 feet below the crown. USACE Sacramento O&M Manual 106, May 1953, (Station 294+49 ""A""), invert elevation 14.4 feet]. FS Date: 10/2/2018 2:10:00 PM

WS view: concrete headwall, flap gates on 36" CMP (left) and 60" CMP (right)

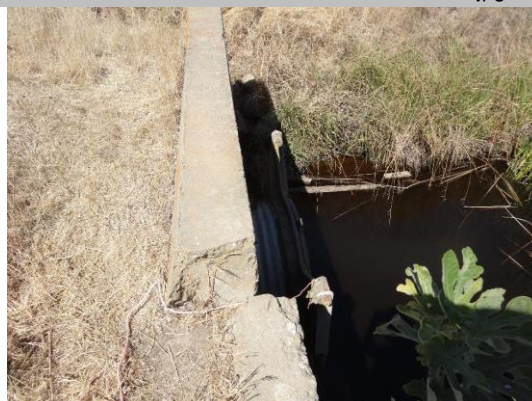
Photo 2 of 3 : UCIP_SP_2020_53360_34770.jpg

WS view: cracked and tilted concrete headwall.

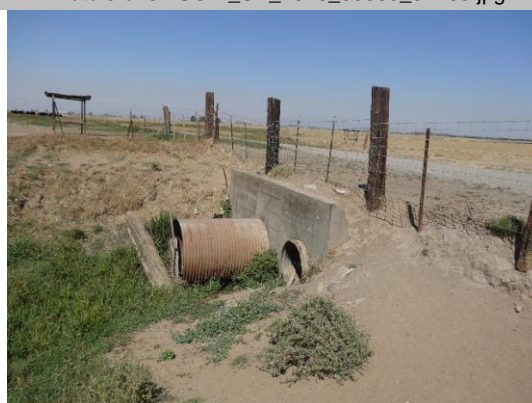
Photo 3 of 3 : UCIP_SP_2020_53360_34769.jpg

LS view: concrete headwall, 36" CMP (right) and 60" CMP (left)

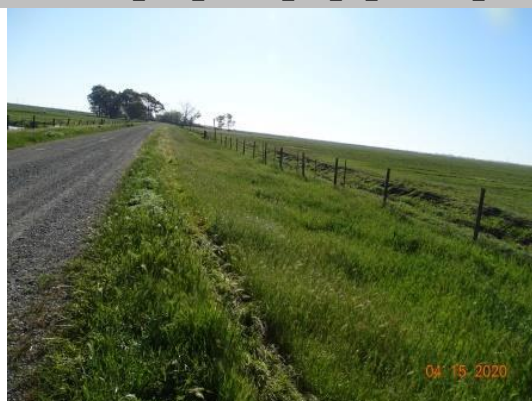
Photo 1 of 1 : SP_2020_RD0536_208_19_20200415_00061.jpg

LM Start	0.02	Rating **	M	Issue No.	19
LM End	1.76	Issue Type +	Ma	Location *	LS
Category	Earthen Levee			GPS Latitude/Longitude	
				Start	End
Item	Vegetation			38.244981 °	38.259695 °
				-121.768504 °	-121.750109 °
DWR ID	DWR_RD0536_01_s_2020_19				
Comment Code					
V1 : Control annual grass and weeds on the levee slopes and easements.					
Inspector Comment

View looking downstream at annual vegetation on the landside slope (Spring 2020).

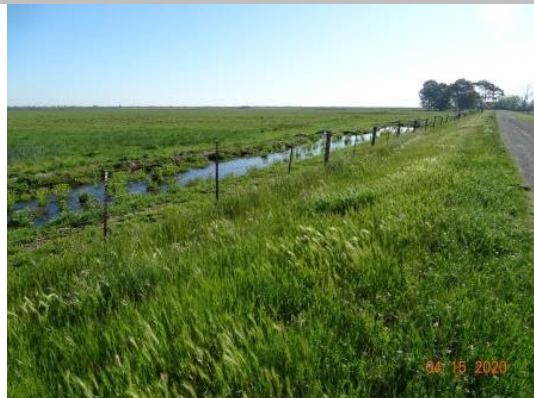
Photo 1 of 1 : SP_2020_RD0536_208_21_20200415_00060.jpg

View looking downstream at annual vegetation on the waterside slope (Spring 2020).

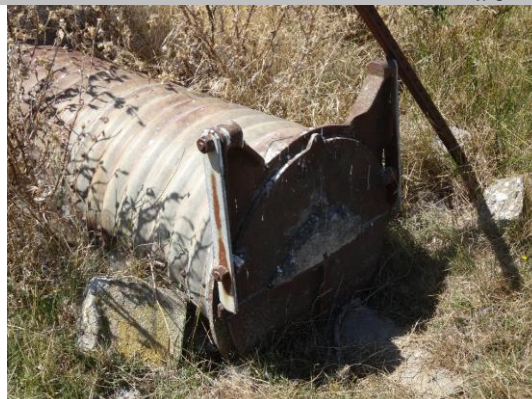
Photo 2 of 3 : UCIP_SP_2020_49313_34773.jpg

WS view: CM pipe blocked by concrete debris on levee slope.

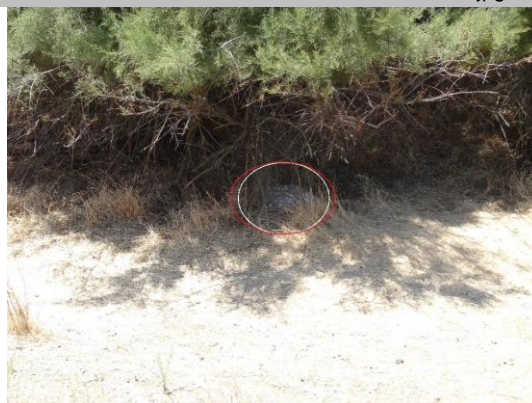
Photo 3 of 3 : UCIP_SP_2020_49313_34772.jpg

LS view: open CM pipe end on levee slope.

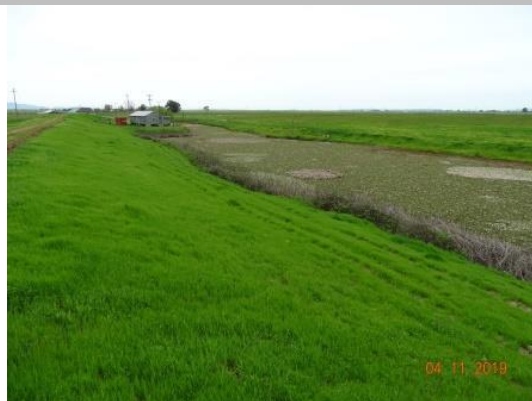
Photo 1 of 2 : SP_2020_RD0536_208_14_20200304_00002.jpg

LM Start	0.34	Rating **	M	Issue No.	30
LM End	0.34	Issue Type +	Ma	Location *	CR
Category	Earthen Levee			GPS Latitude/Longitude	
				Start	End
Item	Crown Surface / Depressions / Rutting			38.245615 °	38.245615 °
				-121.762820 °	-121.762820 °
DWR ID	DWR_RD0536_01_s_2020_30				
Comment Code					
C2 : Repair depressions or ruts in the crown or slope.					
Inspector Comment

View looking upstream at cow ruts on the waterside slope (Spring 2019).

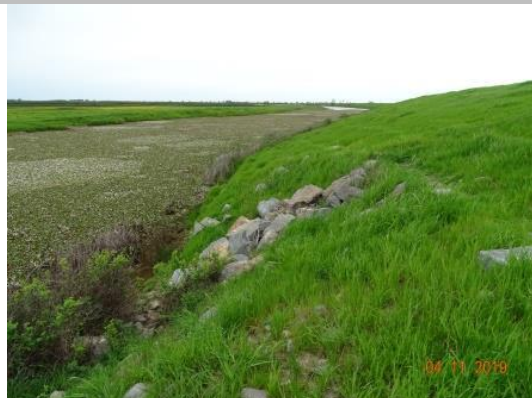
Photo 2 of 2 : SP_2020_RD0536_208_14_20200304_00003.jpg

View looking downstream at erosion spot with rock placed on it (Spring 2019).

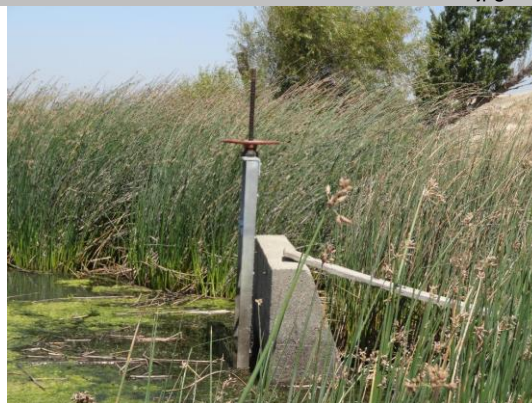
Photo 1 of 2 : UCIP_SP_2020_20444_34493.jpg

DS_ID:22715
 FS_ID:20444
 EP_NO: 10115
 Repair Type: No Action Needed
 Crossing Status: Found
 UCIP Comments: Pipe was submerged into water and not visible. Steel bar fence on both sides of the levee.
 FIELD_STRUCT_DESC: 42-inch corrugated metal gravity drainage pipe through the levee, 22.5 feet below the crown. Concrete headwall on each end. Screw gate on the waterside (WS) end. (Retention of a 42-inch drainage pipe through the levee, 22.5 feet below the crown, and a slide gate on the WS end authorized under Automatic Board Order (ABO) issued as Permit No. 10115, 1974 - Petersen Estate Company, care of R. Moss. [Additional Reference(s): DWR Levee Log, 1992. USACE Sacramento O&M Manual 106, May 1953, (Station 238+36 ""A""), invert elevation 1.5 feet].
 FS Date: 8/13/2013

WS view: slide gate, concrete headwall in the channel. Pipe submerged into water.

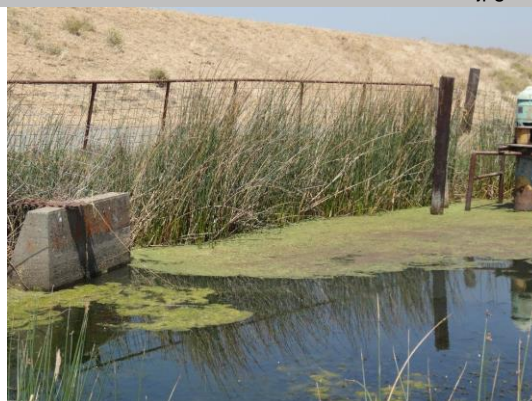
Photo 2 of 2 : UCIP_SP_2020_20444_34492.jpg

LS view: concrete headwall in the channel/irrigation ditch. Pipe submerged into water.

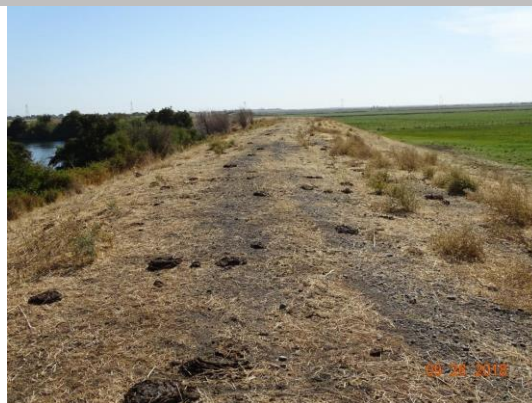
Photo 1 of 1 : SP_2020_RD0536_208_47_20200304_00021.jpg

LM Start	1.14	Rating **	M	Issue No.	47
LM End	1.87	Issue Type +	Ma	Location *	CR
Category	Earthen Levee			GPS Latitude/Longitude	
				Start	End
Item	Crown Surface / Depressions / Rutting			38.256050 °	38.259773 °
				-121.757582 °	-121.748323 °
DWR ID	DWR_RD0536_01_f_2014_47				
Comment Code					
C3 : Add appropriate gravel or road base. Grade and compact.					
Inspector Comment					
Add appropriate gravel to the crown roadway and repair ruts.

View looking downstream of the crown. Gravel should be added to the roadway (September 2018).

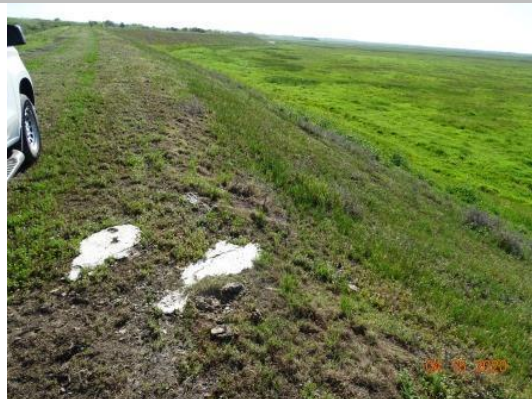
Photo 1 of 1 : SP_2020_RD0536_208_34_20200415_00063.jpg

LM Start	1.35	Rating **	M	Issue No.	34
LM End	1.35	Issue Type +	Ma	Location *	LS
Category	Earthen Levee			GPS Latitude/Longitude	
				Start	End
Item	Slope Stability			38.258927 °	38.258927 °
				-121.756932 °	-121.756932 °
DWR ID	DWR_RD0536_01_s_2020_34				
Comment Code					
S1 : Repair slope instability.					
Inspector Comment					
Dip in the roadway and slope on the landside.

View of dip in the crown and slope on the landside (Spring 2020).

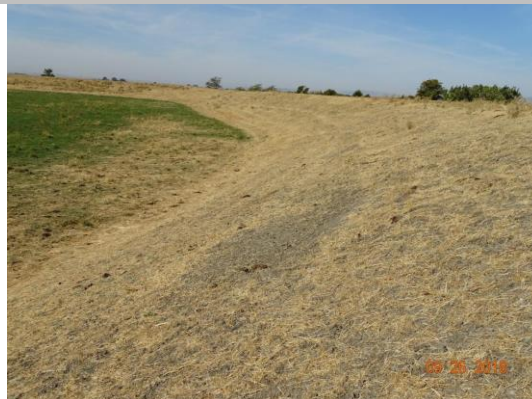
Photo 1 of 1 : SP_2020_RD0536_208_17_20200304_00006.jpg

LM Start	1.45	Rating **	M	Issue No.	17
LM End	1.45	Issue Type +	Ma	Location *	LS
Category	Earthen Levee			GPS Latitude/Longitude	
				Start	End
Item	Slope Stability			38.259087 °	38.259087 °
				-121.755133 °	-121.755133 °
DWR ID	DWR_RD0536_01_f_2018_17				
Comment Code					
S2 : Repair the levee slope damaged by foot traffic and prevent access where possible.					
Inspector Comment					
Depressions in levee due to cows should be repaired to prevent deeper depressions into levee.

View looking upstream at divots in the slope created by cows. Divots are deep enough that they should be corrected (September 2018).

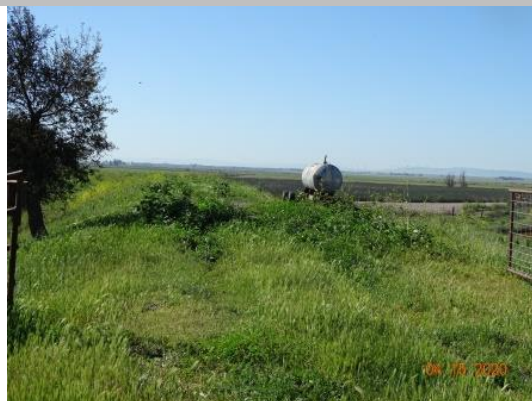
Photo 1 of 1 : SP_2020_RD0536_208_31_20200415_00064.jpg

View looking downstream at vegetation on the crown (Spring 2020).

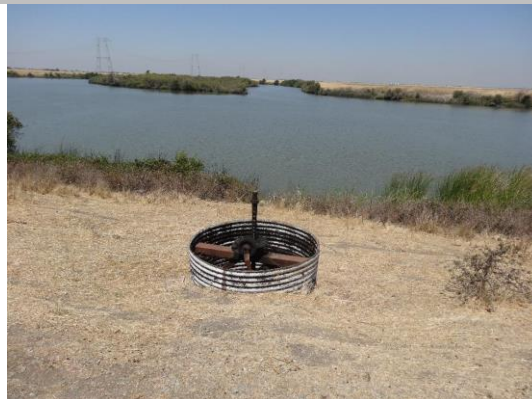
Photo 1 of 3 : UCIP_SP_2020_20503_34568.jpg

DS_ID:22718
FS_ID:20503
EP_NO: 10116
Repair Type: No Action Needed
Crossing Status: Found
UCIP Comments: Vortex seen on WS. Water flow seen on LS. Saddle, apron, and headwall not visible. Inlet and outlet pipe-ends are submerged into water.
FIELD_STRUCT_DESC: 54-inch corrugated metal gravity drainage pipe through the levee, 30 feet below the crown. Screw gate in a pipe riser on the waterside (WS) slope. Saddle, apron, headwall, two corrugated metal cutoff walls, one No. 101 gate, and one No. 102 gate. (Retention of a 54-inch drainage pipe through the levee, 30 feet below the crown, and a slide gate on the WS slope authorized under Automatic Board Order (ABO) 10116, 1974 - Marion Sanchez Farms).
[Additional Reference(s): DWR Levee Log, 1992. USACE Sacramento O&M Manual 106, May 1953, (Station 87+70 ""R""), invert elevation -2 feet].
FS Date: 8/13/2013

WS view: CMP riser with slide gate on levee slope. Water channel on background.

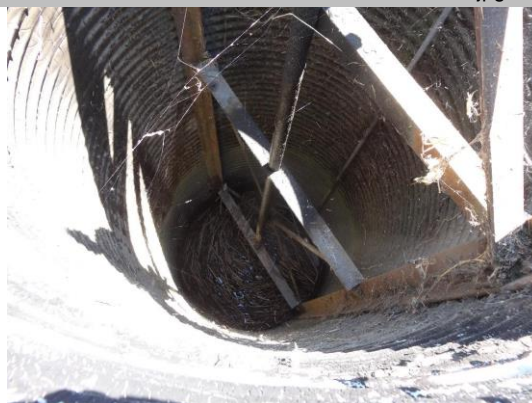
Photo 2 of 3 : UCIP_SP_2020_20503_34567.jpg

WS view: closer view of slide gate in CMP riser on levee slope.

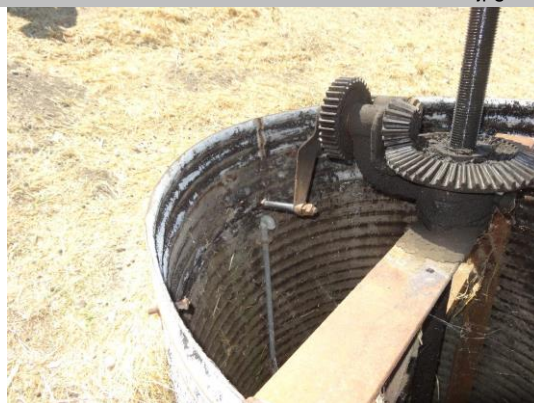
Photo 3 of 3 : UCIP_SP_2020_20503_34566.jpg

WS view: closer view of slide gate in CMP riser on levee slope. Air vent attached to the wall of CMP (left).

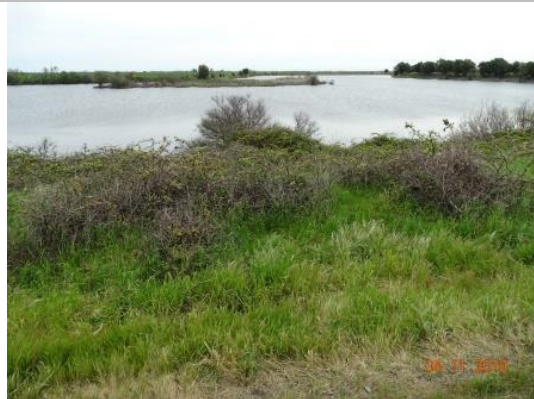
Photo 1 of 1 : SP_2020_RD0536_208_42_20200304_00019.jpg

LM Start	4.21	Rating **	M	Issue No.	42
LM End	4.21	Issue Type +	Ma	Location *	WS
Category	Earthen Levee			GPS Latitude/Longitude	
				Start	End
Item	Vegetation			38.249374 °	38.249374 °
				-121.718622 °	-121.718622 °
DWR ID	DWR_RD0536_01_s_2019_42				
Comment Code					
V2 : Remove the wild growth other than native grasses from the levee slopes.					
Inspector Comment					
Remove blackberries at least 20' from waterside shoulder.

View looking downslope at blackberries on the waterside slope (Spring 2019).

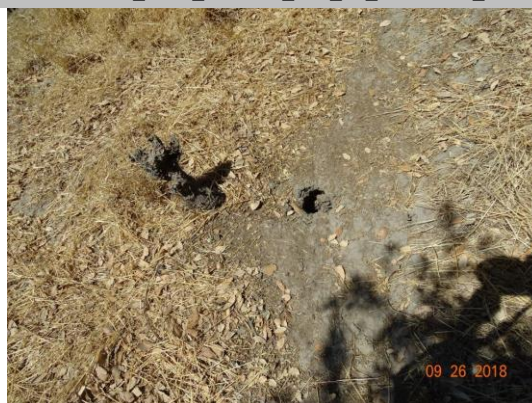
Photo 1 of 1 : SP_2020_RD0536_208_26_20200304_00014.jpg

View of squirrel hole on the landside slope (September 2018).

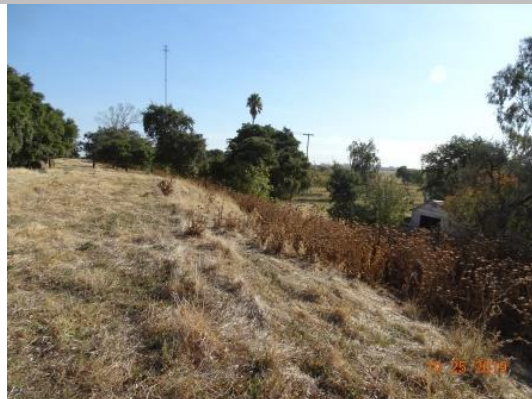
Photo 1 of 1 : SP_2020_RD0536_208_54_20200304_00025.jpg

View looking downstream at vegetation on the landside slope (Fall 2019).

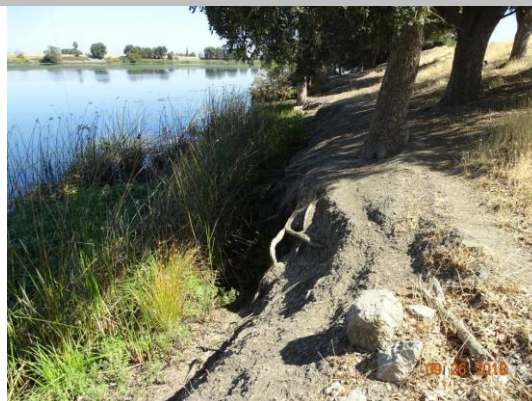
Photo 1 of 1 : SP_2020_RD0536_208_16_20200304_00005.jpg

LM Start	4.94	Rating **	M	Issue No.	16
LM End	4.95	Issue Type +	Ma	Location *	WS
Category	Supplemental			GPS Latitude/Longitude	
				Start	End
Item	2017 USACE Erosion Survey			38.245581 °	38.245667 °
				-121.708605 °	-121.708327 °
DWR ID	DWR_RD0536_01_f_2018_16				
Comment Code					
Inspector Comment					
2017 Site ID: LDS 0.8 R					
Status: Eroding					
2017 Field Notes: additional erosion at toe.					
Site History: 2011 - Multiple erosion pockets from tree popouts. A smaller erosion pocket in the middle of a failing bank repair. Pump structure at the downstream end may be contributing to the erosion.

Deeper erosion at the toe with roots exposed (September 2018).

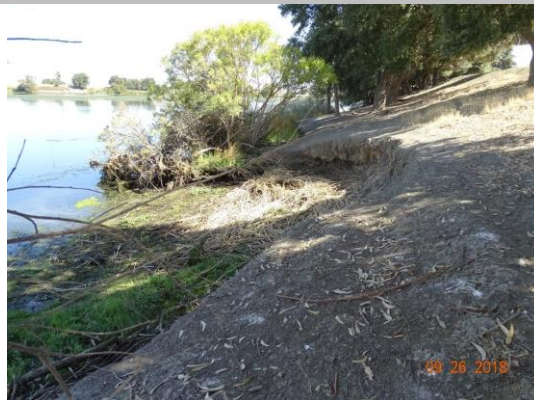
Photo 1 of 1 : SP_2020_RD0536_208_15_20200304_00004.jpg

Large erosion pocket on the waterside slope extends deep into slope (September 2018).

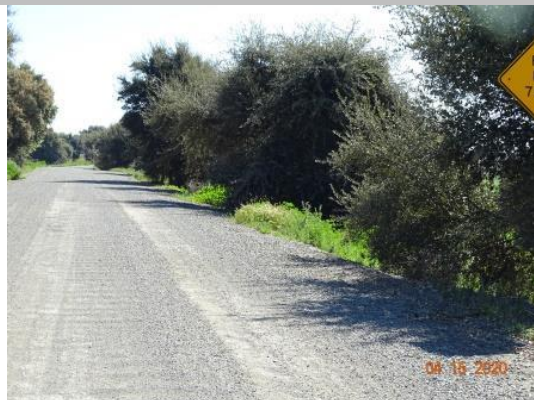
Photo 1 of 1 : SP_2020_RD0536_208_45_20200415_00066.jpg

LM Start	5.18	Rating **	U	Issue No.	45
LM End	5.45	Issue Type +	Ma	Location *	LS
Category	Earthen Levee			GPS Latitude/Longitude	
				Start	End
Item	Vegetation			38.245215 °	38.245597 °
				-121.704693 °	-121.699889 °
DWR ID	DWR_RD0536_01_s_2020_45				
Comment Code					
V1 : Control annual grass and weeds on the levee slopes and easements.					
Inspector Comment

View looking downstream at annual vegetation on the landside slope (Spring 2020).

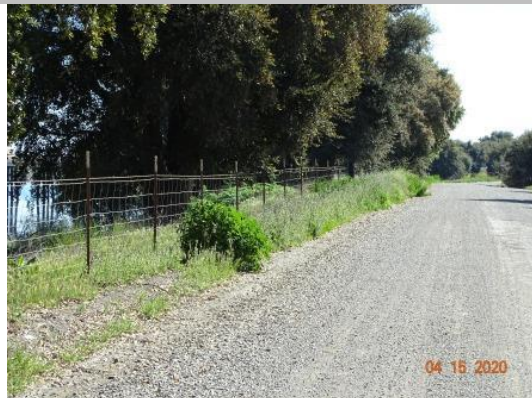
Photo 1 of 1 : SP_2020_RD0536_208_41_20200415_00065.jpg

View looking downstream at annual vegetation on the waterside slope (Spring 2020).

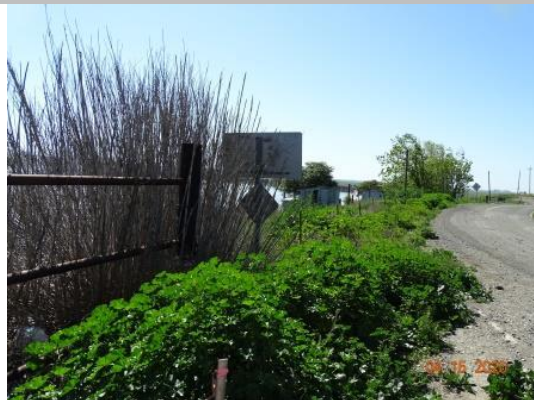
Photo 1 of 1 : SP_2020_RD0536_209_10_20200415_00023.jpg

View looking downstream at annual vegetation on the waterside slope (Spring 2020).

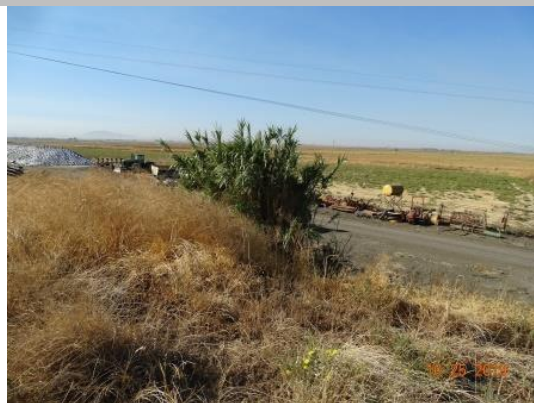
Photo 1 of 1 : SP_2020_RD0536_209_7_20200304_00003.jpg

View looking downslope at arundo on the landside slope (Fall 2019).

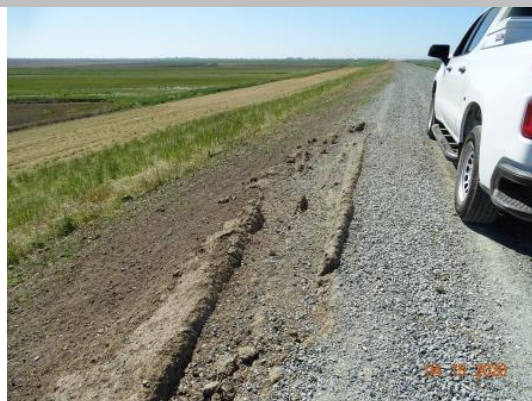
Photo 1 of 1 : SP_2020_RD0536_209_14_20200415_00024.jpg

LM Start	1.17	Rating **	U	Issue No.	14
LM End	1.17	Issue Type +	Ma	Location *	CR
Category	Earthen Levee			GPS Latitude/Longitude	
				Start	End
Item	Crown Surface / Depressions / Rutting			38.228697 °	38.228697 °
				-121.697723 °	-121.697723 °
DWR ID	DWR_RD0536_02_s_2020_14				
Comment Code					
C2 : Repair depressions or ruts in the crown or slope.					
Inspector Comment

View looking downstream at surface depression on the waterside hinge (Spring 2020).

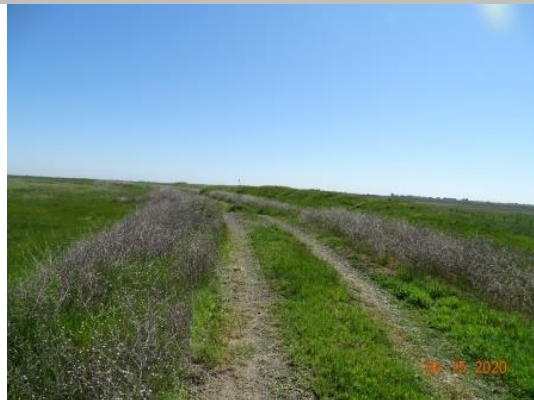
Photo 1 of 1 : SP_2020_RD0536_209_21_20200415_00026.jpg

View looking downstream at annual vegetation on the waterside slope (Spring 2020).

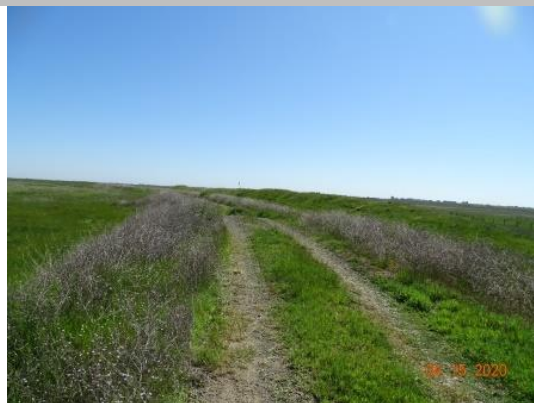
Photo 1 of 1 : SP_2020_RD0536_209_17_20200415_00025.jpg

View looking downstream at annual vegetation on the landside slope (Spring 2020).
